5. Dam Busters: the Breaching of Greenock Reservoirs No.1 & 2

Derek Alexander

National Trust for Scotland, West Region Archaeologist

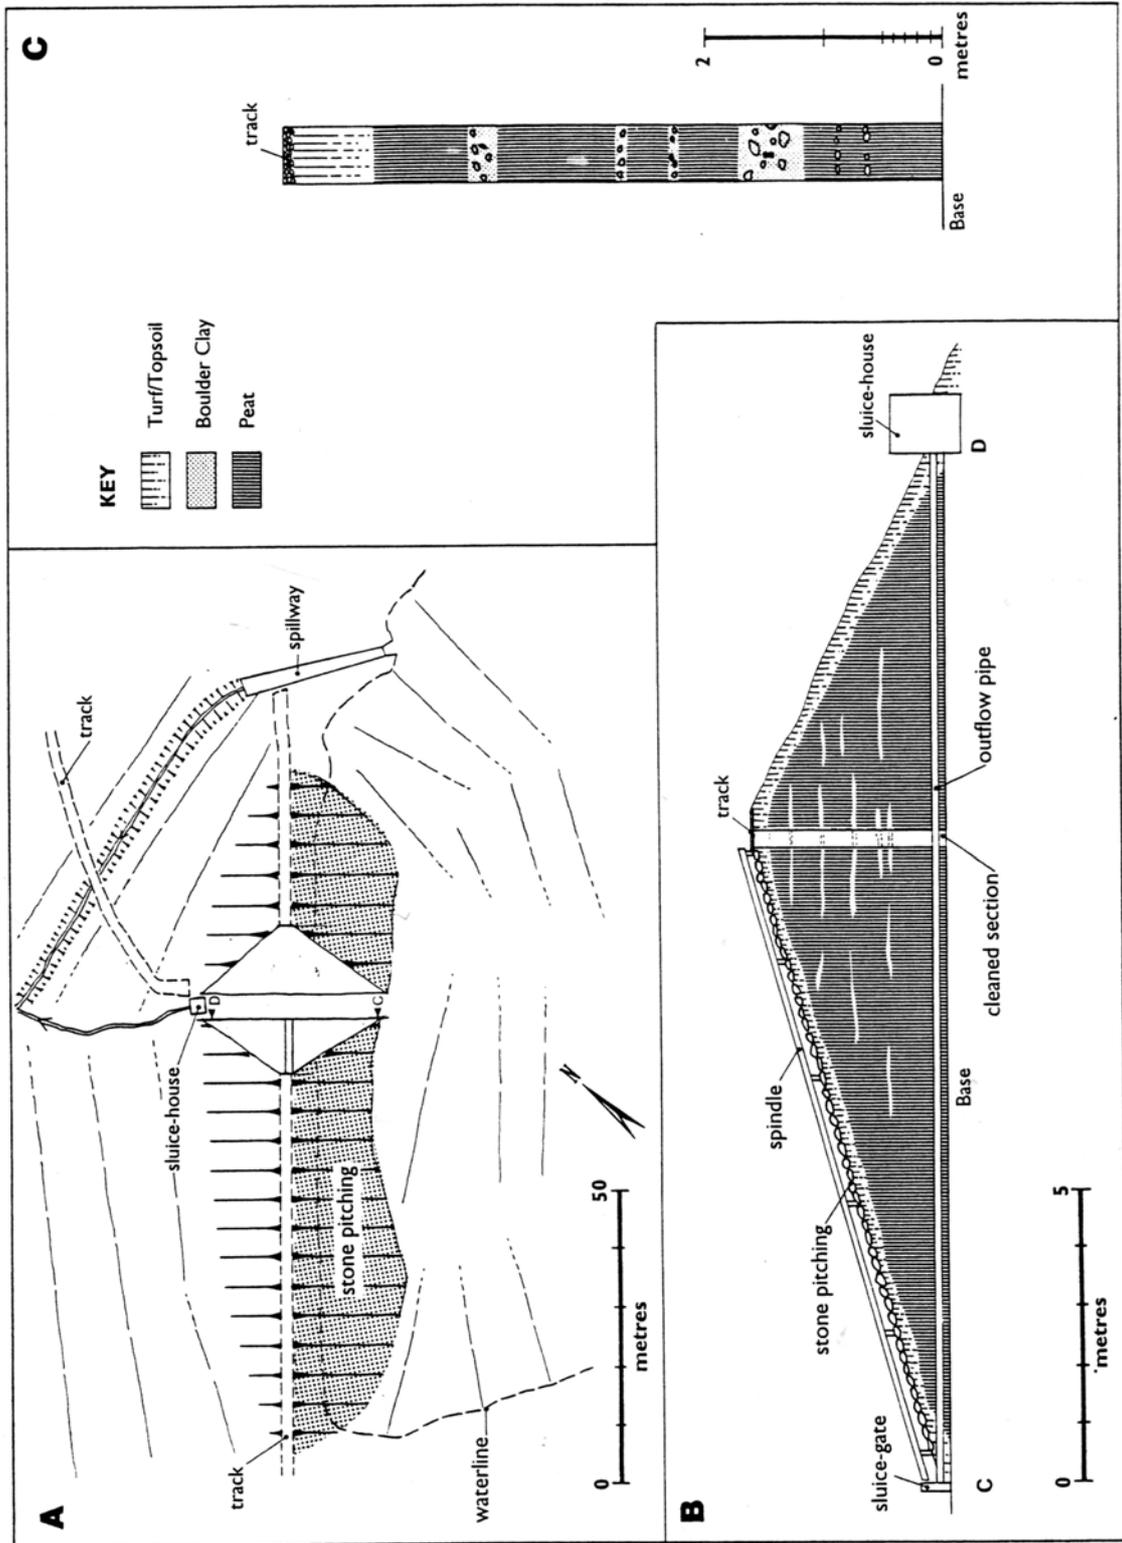
Fig. 2 - Dam 1 plan and sections

Greenock Reservoir No. 1 (NS 240 730) was constructed in 1829 and stands 5.9m high (Fig. 2). Its maximum capacity was 59,700 cubic metres. The dam is c.115m long across its top and is built at the northern end of a shallow natural depression.

Breaching of this dam immediately confirmed Thom's use of peat in dam construction. The inside face of the dam was protected by a layer of stone pitching c. 0.4 – 0.5m thick set within a medium brown silty loam which spread right across the dam. This silty loam was thickest on the dam summit where it underlay a rubble trackway. It also spread down the exterior face underneath the turf covering. Below this the majority of the dam was formed of dark brown/black peat sometimes mixed with stone and clay. This clay clearly contained fragments of branches, which mainly appeared to be birch. It is unclear whether these branches were already incorporated within the peat prior to its use in the construction of the dam or if it

simply reflects a number of small trees that were cleared in the immediate vicinity during dam construction in 1829. However, from the quantity of wood material and the recent recovery of bands of birch material from peat bogs elsewhere in the Renfrewshire uplands, most notably in Muirshiel Country Park, it is most likely that this wood was within the peat and could be thousands of years old. Thom specifically mentions the spreading of alternate layers of puddled peat or alluvial earth (clay) and gravel, beating them together with wooden dumpers until completely mixed. Layers of boulder clay and fragmented rock were recovered throughout the profile of the dam but these were always very thin layers or lenses.

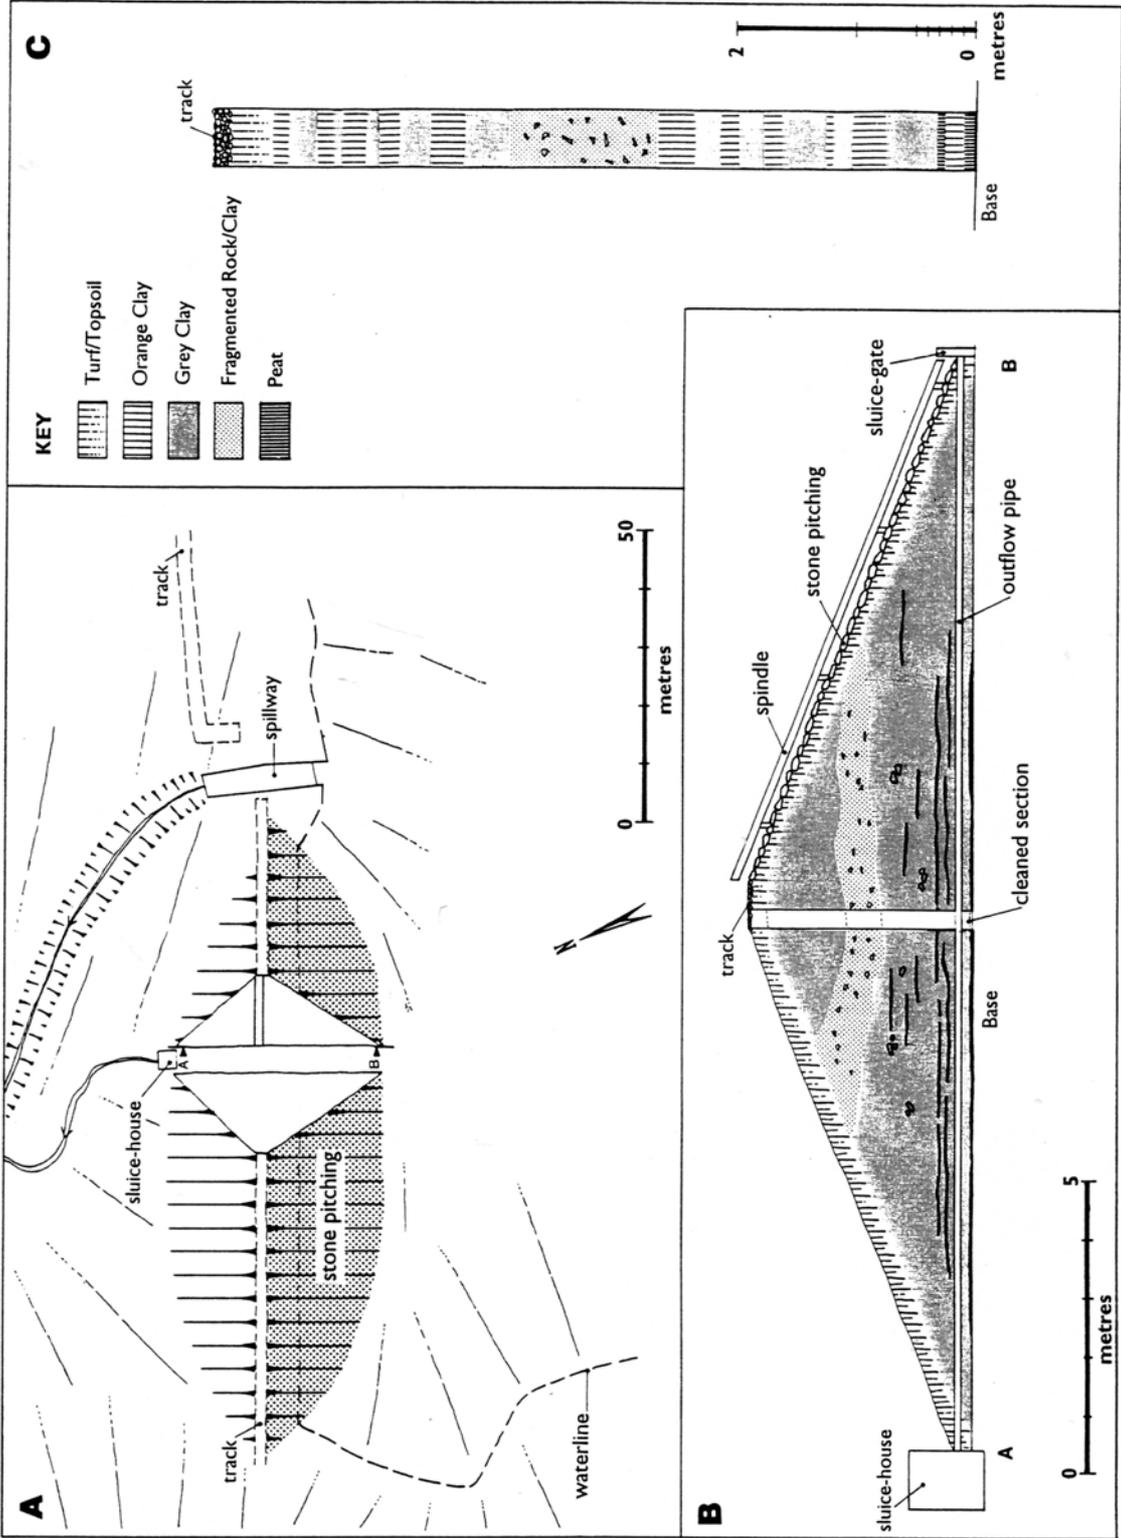
Fig. 3 - Dam 2 plan and sections

Greenock Reservoir No. 2 (NS 239 734) was constructed in 1829 and stands 6.7m high (Figs. 3). Its maximum capacity was 27,100 cubic metres. The dam is c.110m long across its top and links two natural hillocks on either side of a small stream.

Breaching of Dam 2 revealed a remarkably different make up to Dam 1. The superficial covering of the dam was the same with stone pitching on the interior, turf on the exterior, and a track along the summit. In addition the associated features such as the spindle, sluice gate and manhole were similar to those recorded on Dam 1. However, the fill of the dam itself was completely different being constructed mainly of bands of clay rather than peat. Peat was noticeably absent apart from a couple of narrow bands towards the base. The majority of the dam was made of layers of grey and orange boulder clay although there was a noticeably looser band of fragmented rock and clay, c. 1 - 1.5m thick, in the middle. There were also more stones in the lower portion of the dam.
