1. Excavation of Barrhouse, Neilston Anne Macdonald

Figure 1: Barrhouse Survey Drawing, 1994

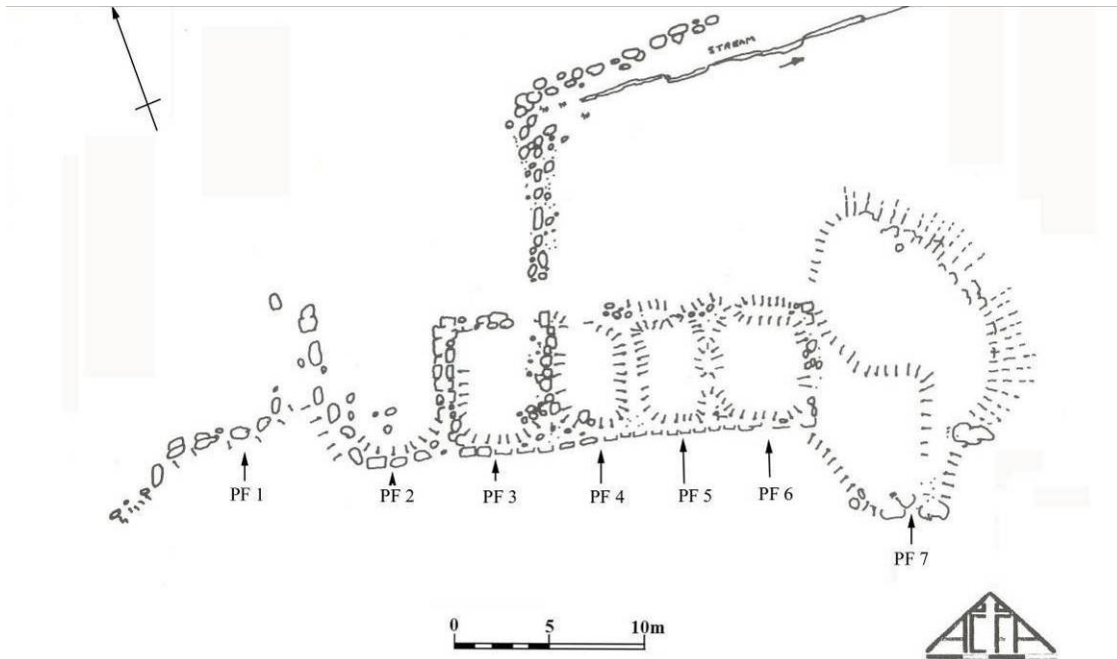
Working from west to east the building was divided into seven sectors, PF1 to PF7

(Figure 1). In June 1998, a small group of Forum members started excavating the section of the structure which had the best upstanding remains (PF3). After large quantities of stone, timbers and corrugated tin roofing were removed the excavators reached the floor. This was the first real diagnostic feature to be uncovered. Substantial well-dressed flagstones measuring up to 1m by 0.5m were quickly revealed. Clearing the rubble towards the south wall revealed a gap of about 0.5m between the edge of the flagstone area and the wall. To the east side the flagstones deteriorated into flat but rough stones largely covered with cinders. The fine flagstone floor only covered about half of the compartment. The remaining northern half of the floor consisted of a 50mm deep layer of beaten cinders and gravel. With the removal of fallen stones which had become embedded in this layer, the surface soon crumbled. Removing the cinders revealed an earlier floor of regularly set cobbles and the edge of the flagstoned area tapered down to the level of these cobbles.

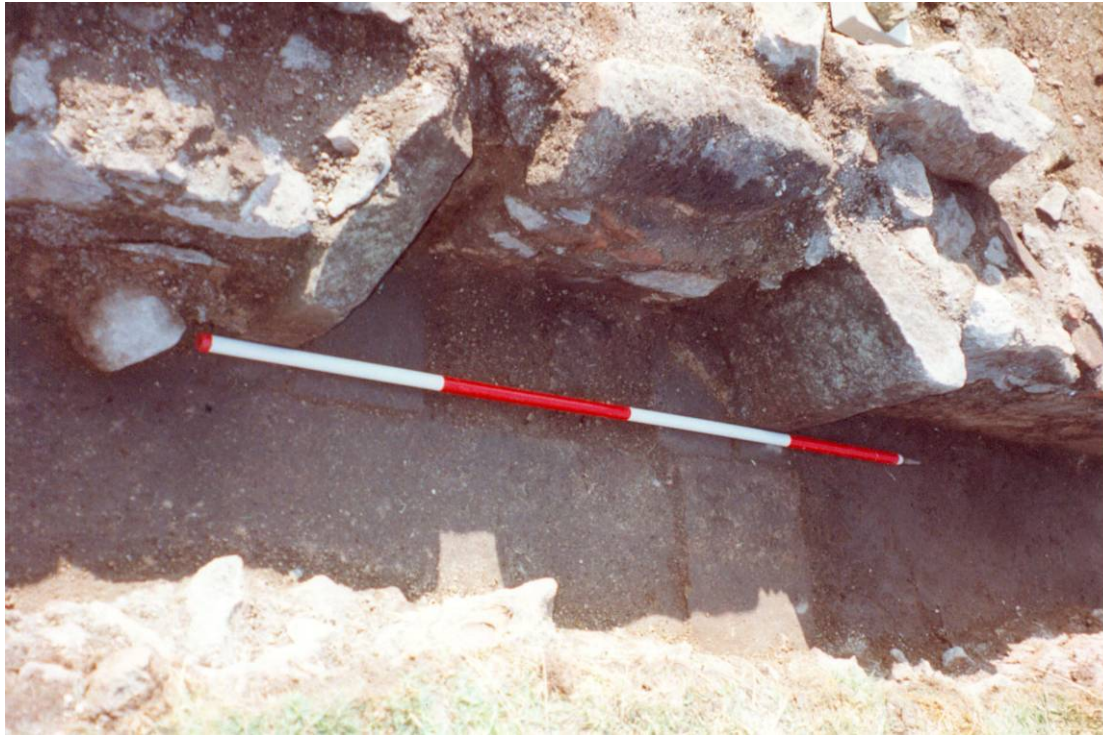
Figure 4: The Fireplace

On excavation, Sector 5 proved to be a kitchen/living room. Midway in the west wall a fireplace was uncovered with good side and back stones and a large flat hearthstone. Unfortunately, the back and side stones of the fireplace were knocked

over and smashed by vandals – the only occasion when vandalism was a problem. The west wall was covered with a lime plaster. As was revealed on the other side of the wall, the structure was very poorly built with small stones, bricks and even pieces of tile field-drain and a total lack of facing stone. Where the plaster had peeled away the wall was rapidly disintegrating. For safety reasons it was necessary to reduce the remaining height of this section of wall by removing the looser rubble on top.

Beyond the fireplace to the south, the wall was of better construction, at least having facing stone behind the plaster. Abutting the south wall a recess was formed, 0.85m wide and 0.3m deep. It also was well constructed with the same type of facing stone and plaster as the adjacent wall. A considerable amount of china and pottery sherds were found in the rubble here, resulting in this being named the “china cabinet”. Some of the broken sherds were later found to be partially burnt and it was concluded that at the end of the use of the house there had been a fire. There was a window in the north wall in Sector 5 and, as well as the door into Sector 4, there was a door leading into a narrow ‘lobby’ which ran through the length of the house and had an external door at each end.

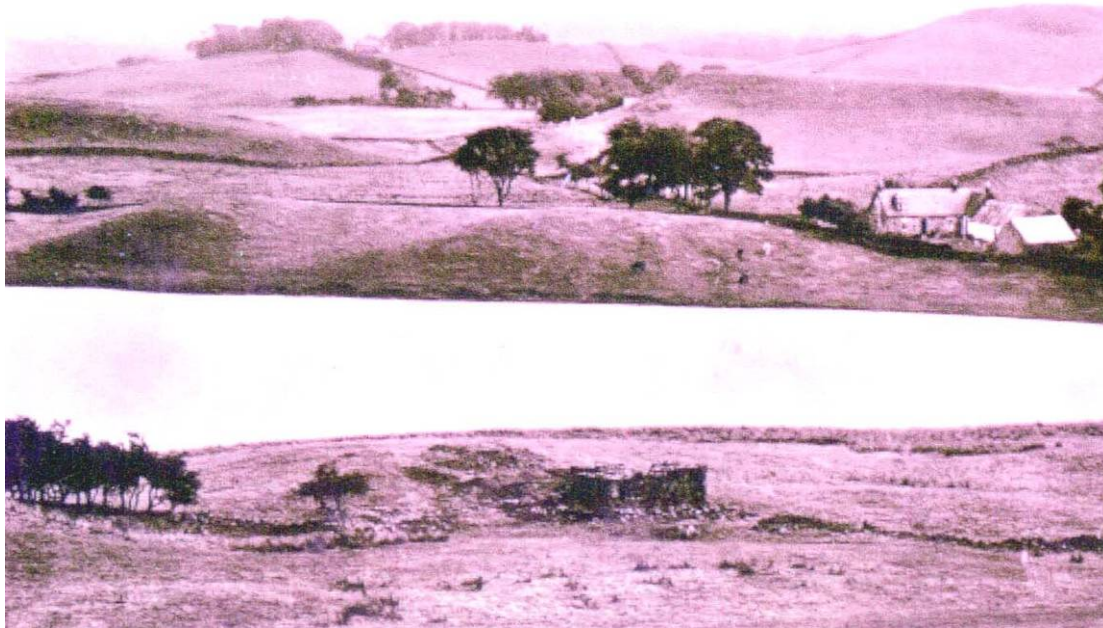
Figure 6: Barrhouse (ruin in foreground and loch in centre) circa 1890

farmhouse with a 2-roomed house connected to a long byre. The byre was later divided into a byre accessed from outside and a dairy accessed from the house. Later still, the house itself was abandoned, possibly following a fire, and the byre at the end of the building was used until late in the 19th century as a place for storage and working with the animals which were using the grasslands of Barrhouse although the farmer lived at Craig of Neilston.
